Trackbed Investigation

METROWEST
PHASE 1
Factual Report

47070043/WT/PL/140569/1

METROWEST
PHASE 1
Interpretative Report

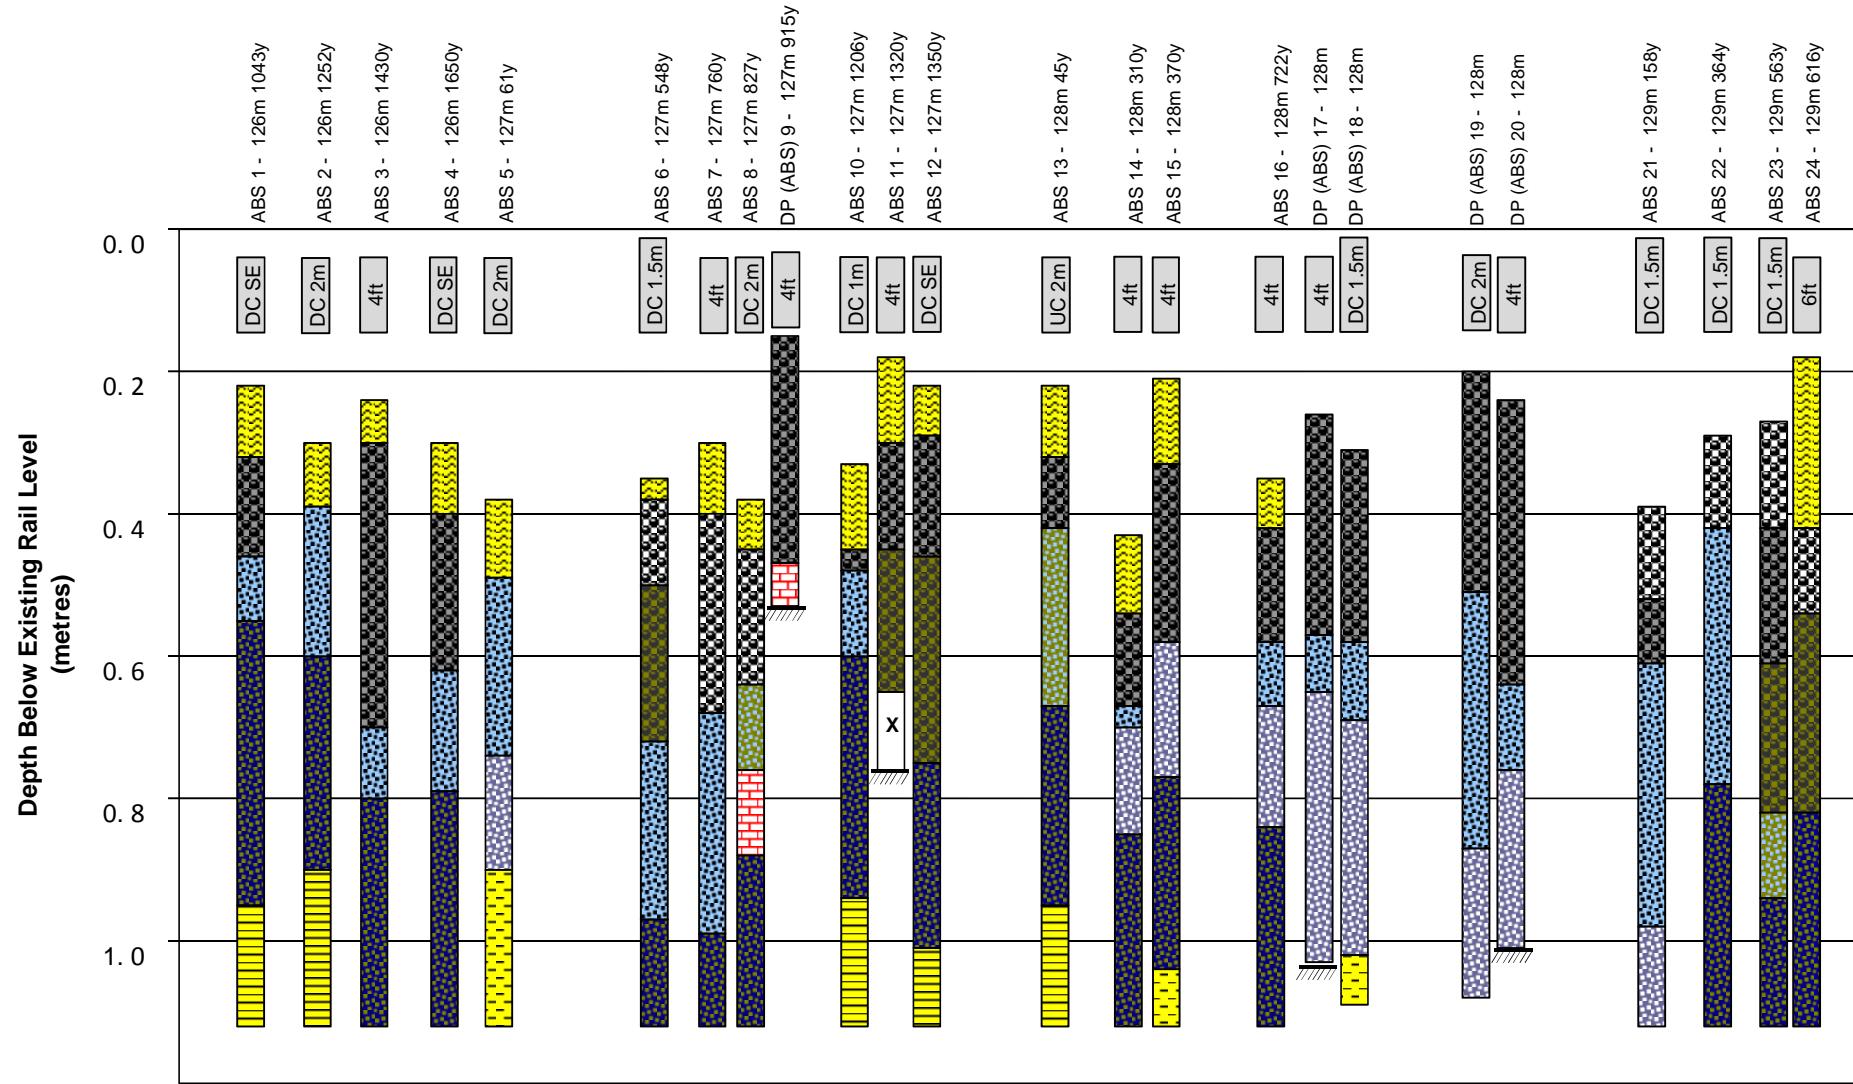
FIGURE 1A:

FIGURE 1A
Metrowest Phase 1 - Trackbed Investigation
LONGITUDINAL SECTION
POD - REVERSIBLE - 126m 1043y to 129m 616y

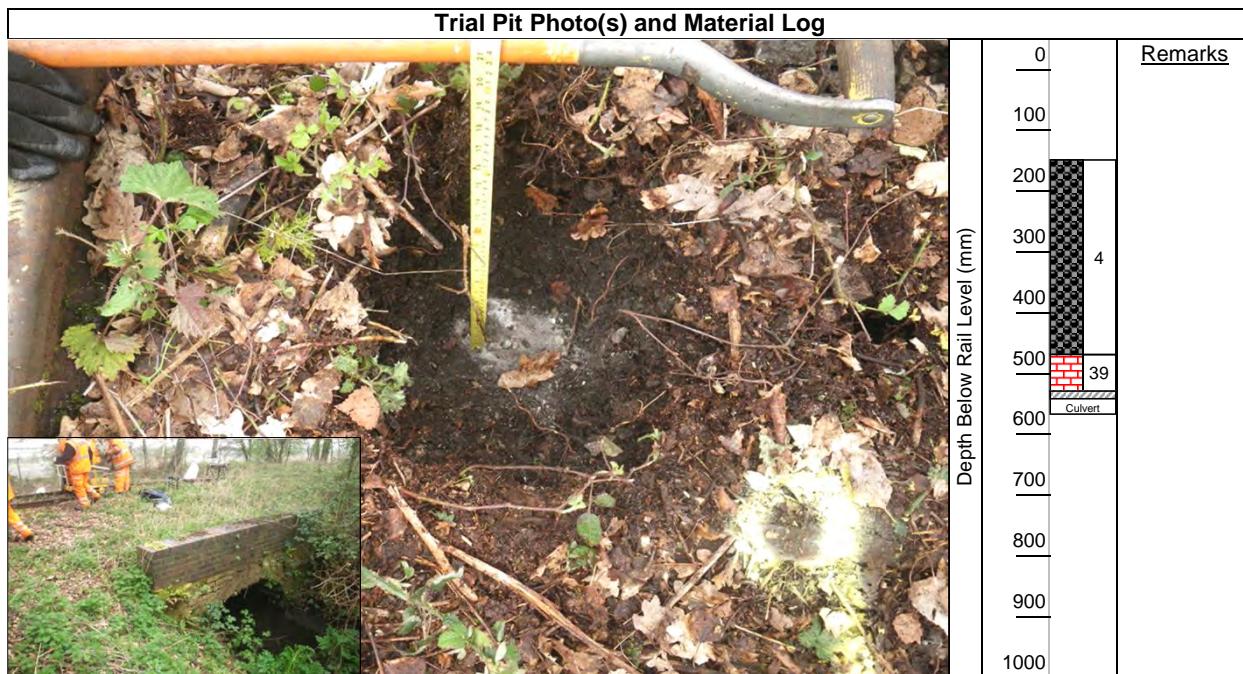
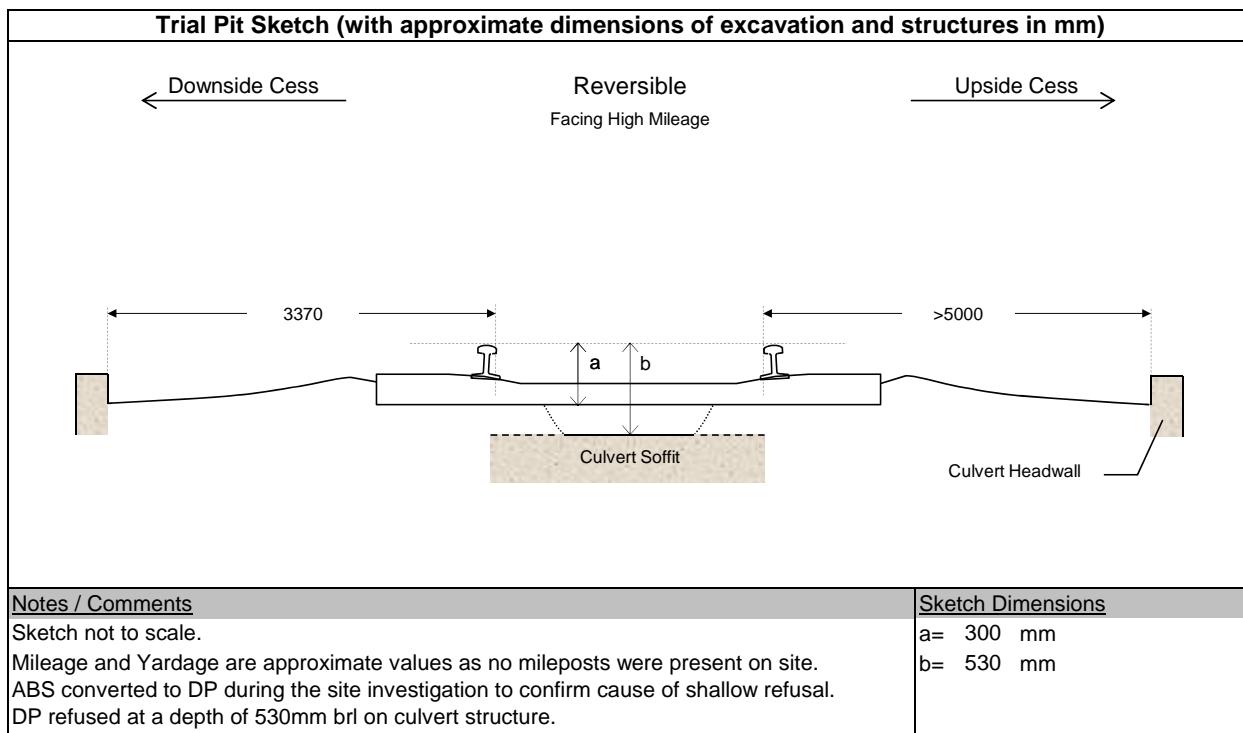
Prepared	JWM	APPENDIX B - DP ABS 9 Metrowest Phase 1 - Trackbed Investigation TRIAL PIT LOG POD - REVERSIBLE
Checked	DGK	
Job No	47070043	
Date	Apr '14

Trial Pit Details					
Pit Type / Number		DP ABS 9	Trial Pit Purpose		Assess clearances to Culvert
Mileage		127m 915y	Reason for termination		Structure encountered
Line Position		Reversible 4ft	Structure Reference		Unknown
Rail Type		Flat Bottom JR	Trackbed conditions encountered (mm below rail level)		
Sleeper Type		Timber	Wet Material		None
Weather	Prior SI	Dry	Standing Water		None
	During SI	Dry	Slurry Material		None
Date of Inspection		03/04/2014	Geosynthetics	Depth	None
Inspected by		JWM	Type		N/A

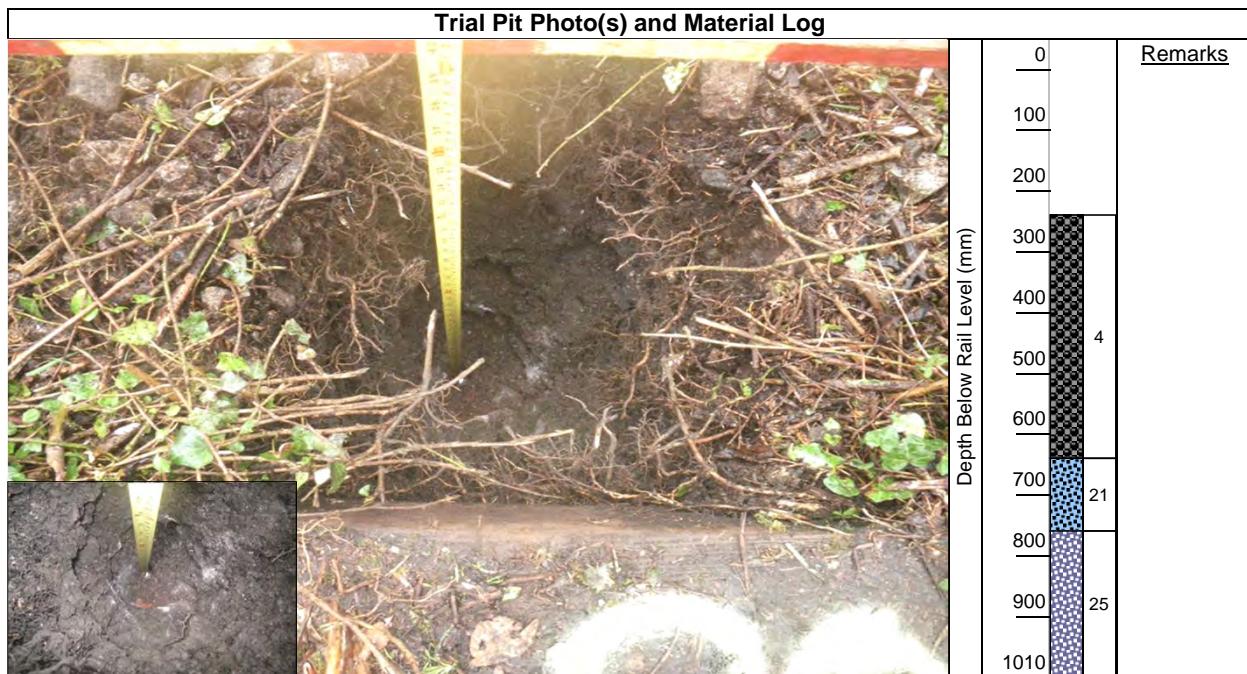
Trial Pit Details					
Pit Type / Number	DP ABS 20		Trial Pit Purpose	Assess clearances to Culvert	
Mileage	128m	913y	Reason for termination	Design depth achieved	
Line Position	Reversible	4ft		Structure Reference	
Rail Type	Flat Bottom JR		Trackbed conditions encountered (mm below rail level)		
Sleeper Type	Timber		Wet Material	None	
Weather	Prior SI During SI	Wet Dry	Standing Water	None	
Date of Inspection	02/04/2014		Slurry Material	None	
Inspected by	JWM		Geosynthetics	Depth	None
			Type		N/A

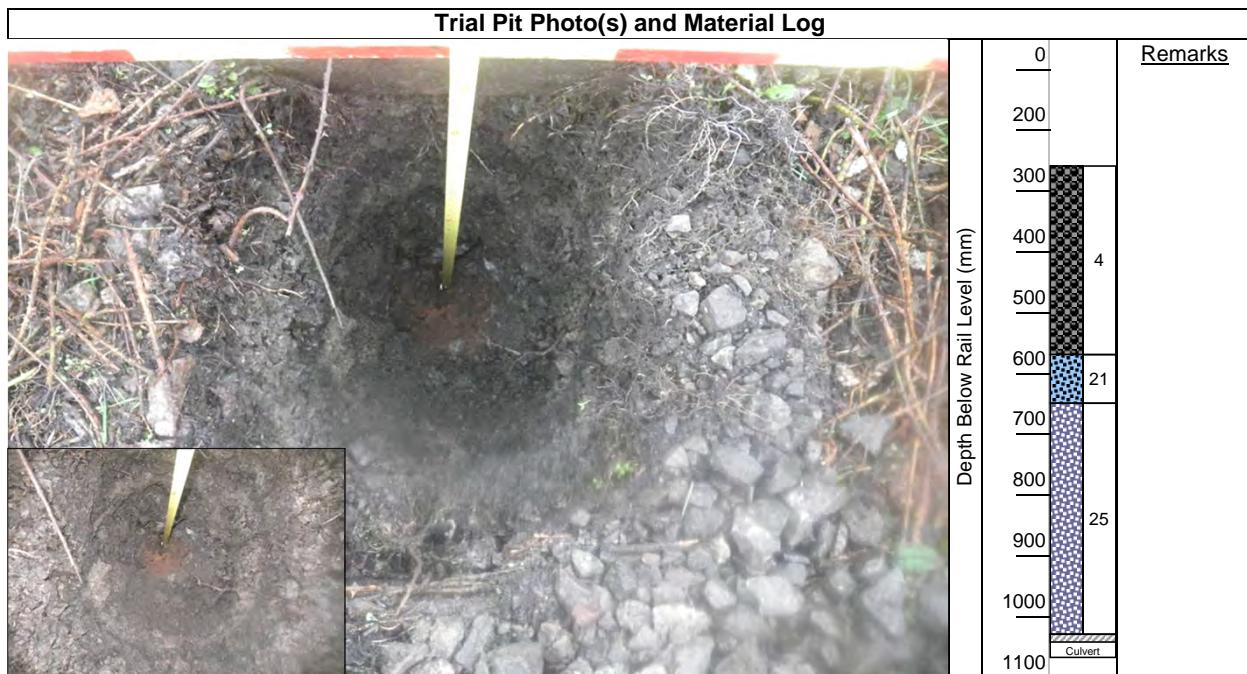
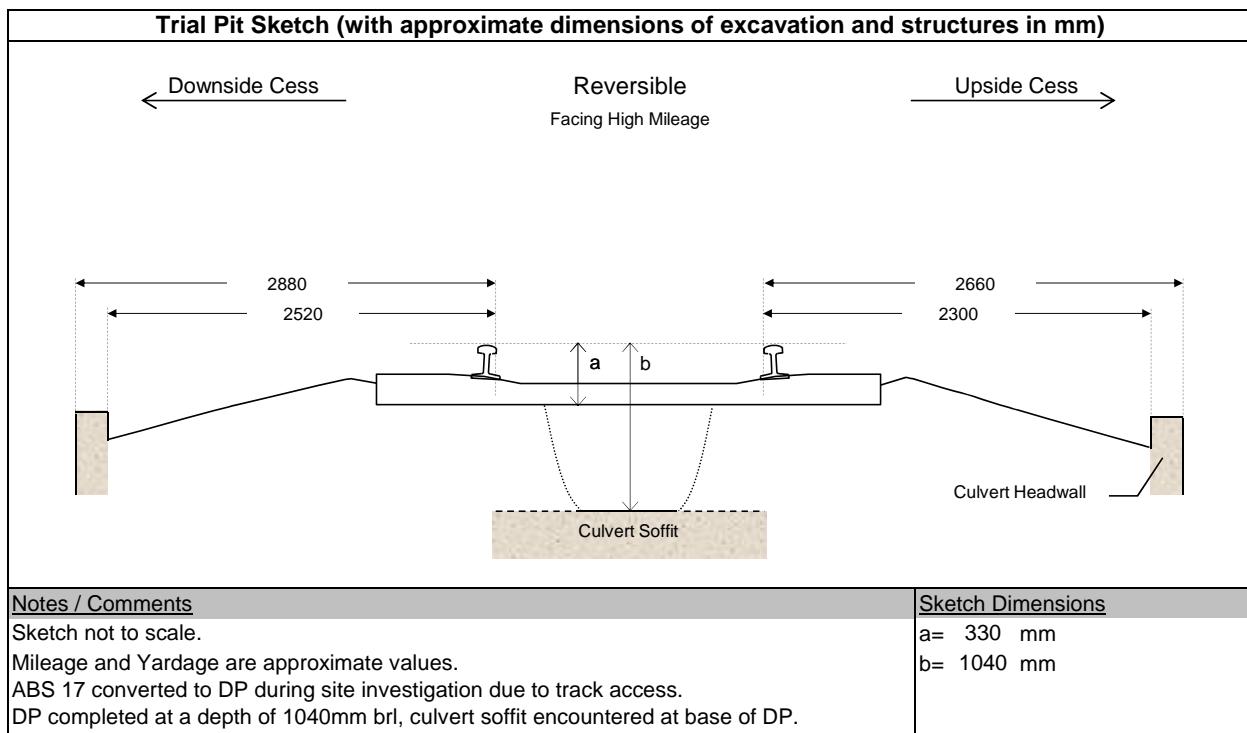
Prepared	JWM	APPENDIX B - DP ABS 17 Metrowest Phase 1 - Trackbed Investigation TRIAL PIT LOG POD - REVERSIBLE
Checked	DGK	
Job No	47070043	
Date	Apr '14

Trial Pit Details					
Pit Type / Number	DP ABS 17		Trial Pit Purpose	Assess clearances to Culvert	
Mileage	128m	923y	Reason for termination		Structure encountered
Line	Reversible		Structure Reference		Unknown
Position	4ft		Trackbed conditions encountered (mm below rail level)		
Rail Type	Flat Bottom JR		Wet Material	None	
Sleeper Type	Timber		Standing Water	None	
Weather	Prior SI During SI	Wet Wet	Slurry Material	None	
Date of Inspection	02/04/2014		Geosynthetics	Depth	None
Inspected by	JWM		Type	N/A

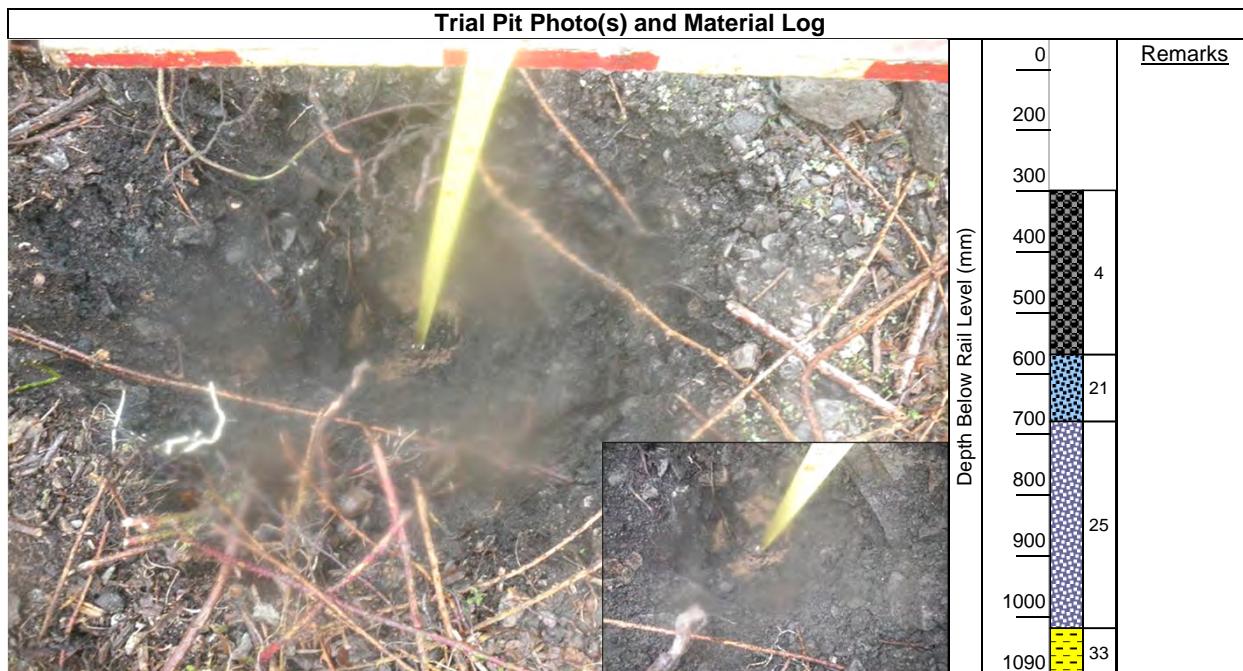
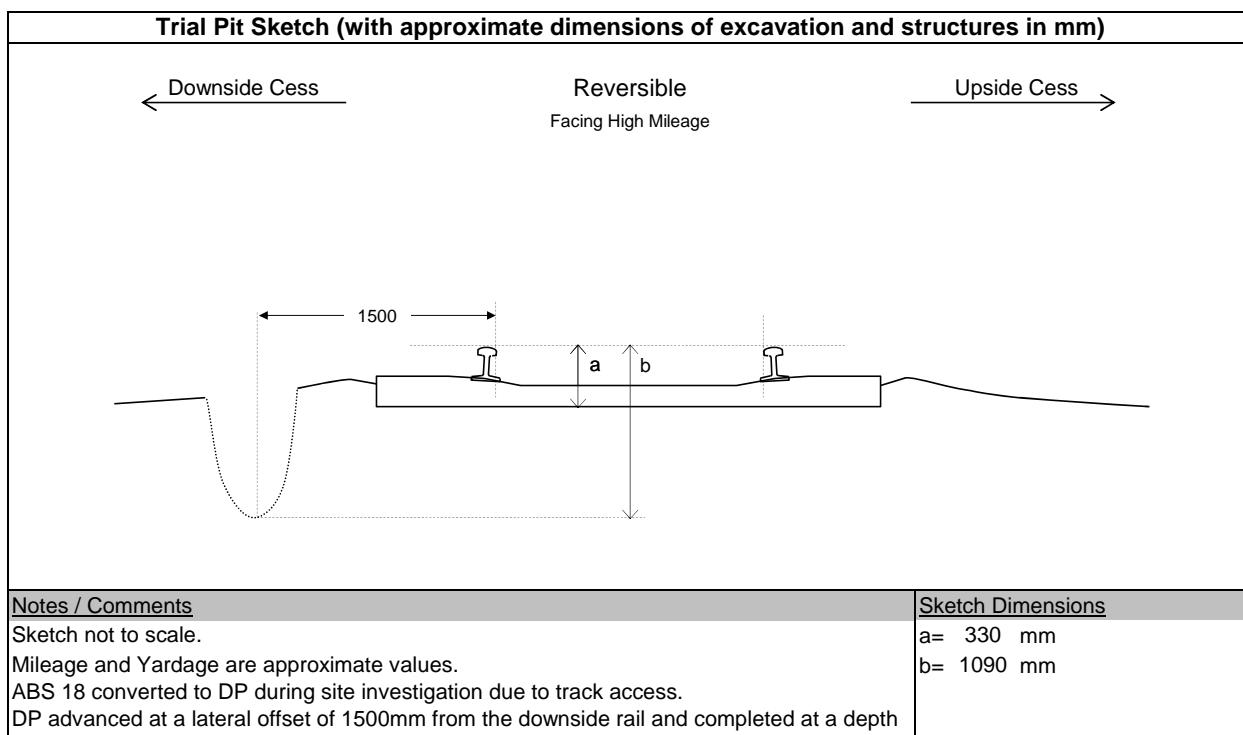
Trial Pit Details							
Pit Type / Number		DP ABS 18		Trial Pit Purpose		ABS Replacement	
Mileage		128m	1385y	Reason for termination		Design depth achieved	
Line Position		Reversible	Cess				
Rail Type		Flat Bottom JR		Trackbed conditions encountered (mm below rail level)			
Sleeper Type		Timber		Wet Material		None	
Weather	Prior SI During SI	Wet Wet		Standing Water		None	
Date of Inspection		02/04/2014		Slurry Material		None	
Inspected by		JWM		Geosynthetics	Depth	None	
					Type	N/A

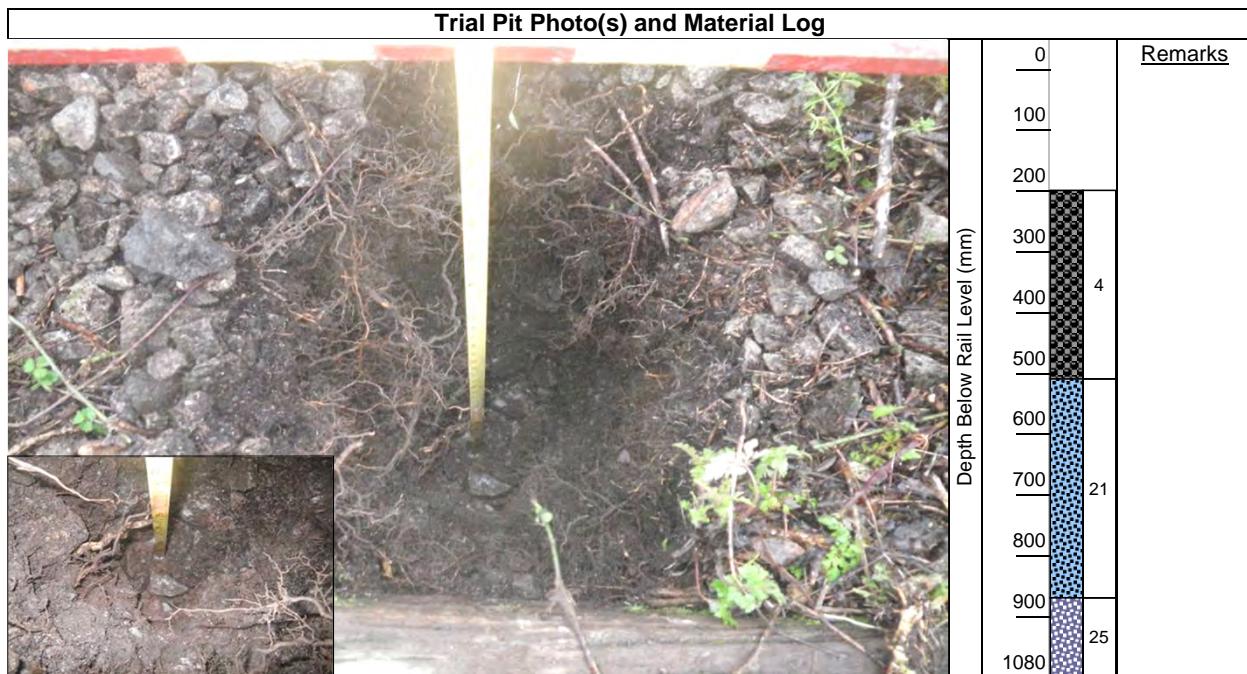
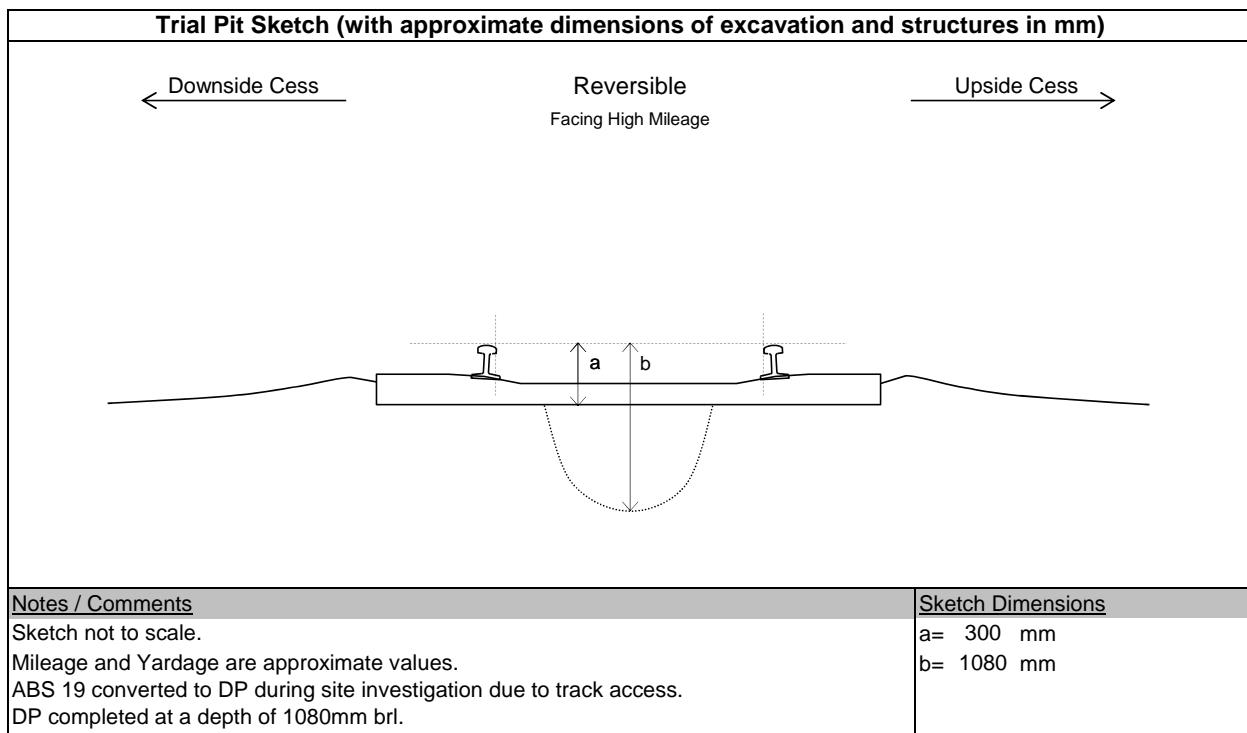
Trial Pit Details					
Pit Type / Number		DP ABS 19		Trial Pit Purpose	
Mileage		128m	1463y	Reason for termination	
Line		Reversible		Design depth achieved	
Position		4ft		Structure Reference	
Rail Type		Flat Bottom JR		Trackbed conditions encountered (mm below rail level)	
Sleeper Type		Timber		Wet Material	None
Weather	Prior SI During SI	Wet Dry		Standing Water	None
				Slurry Material	None
Date of Inspection		02/04/2014		Geosynthetics	None
Inspected by		JWM		Depth Type	N/A

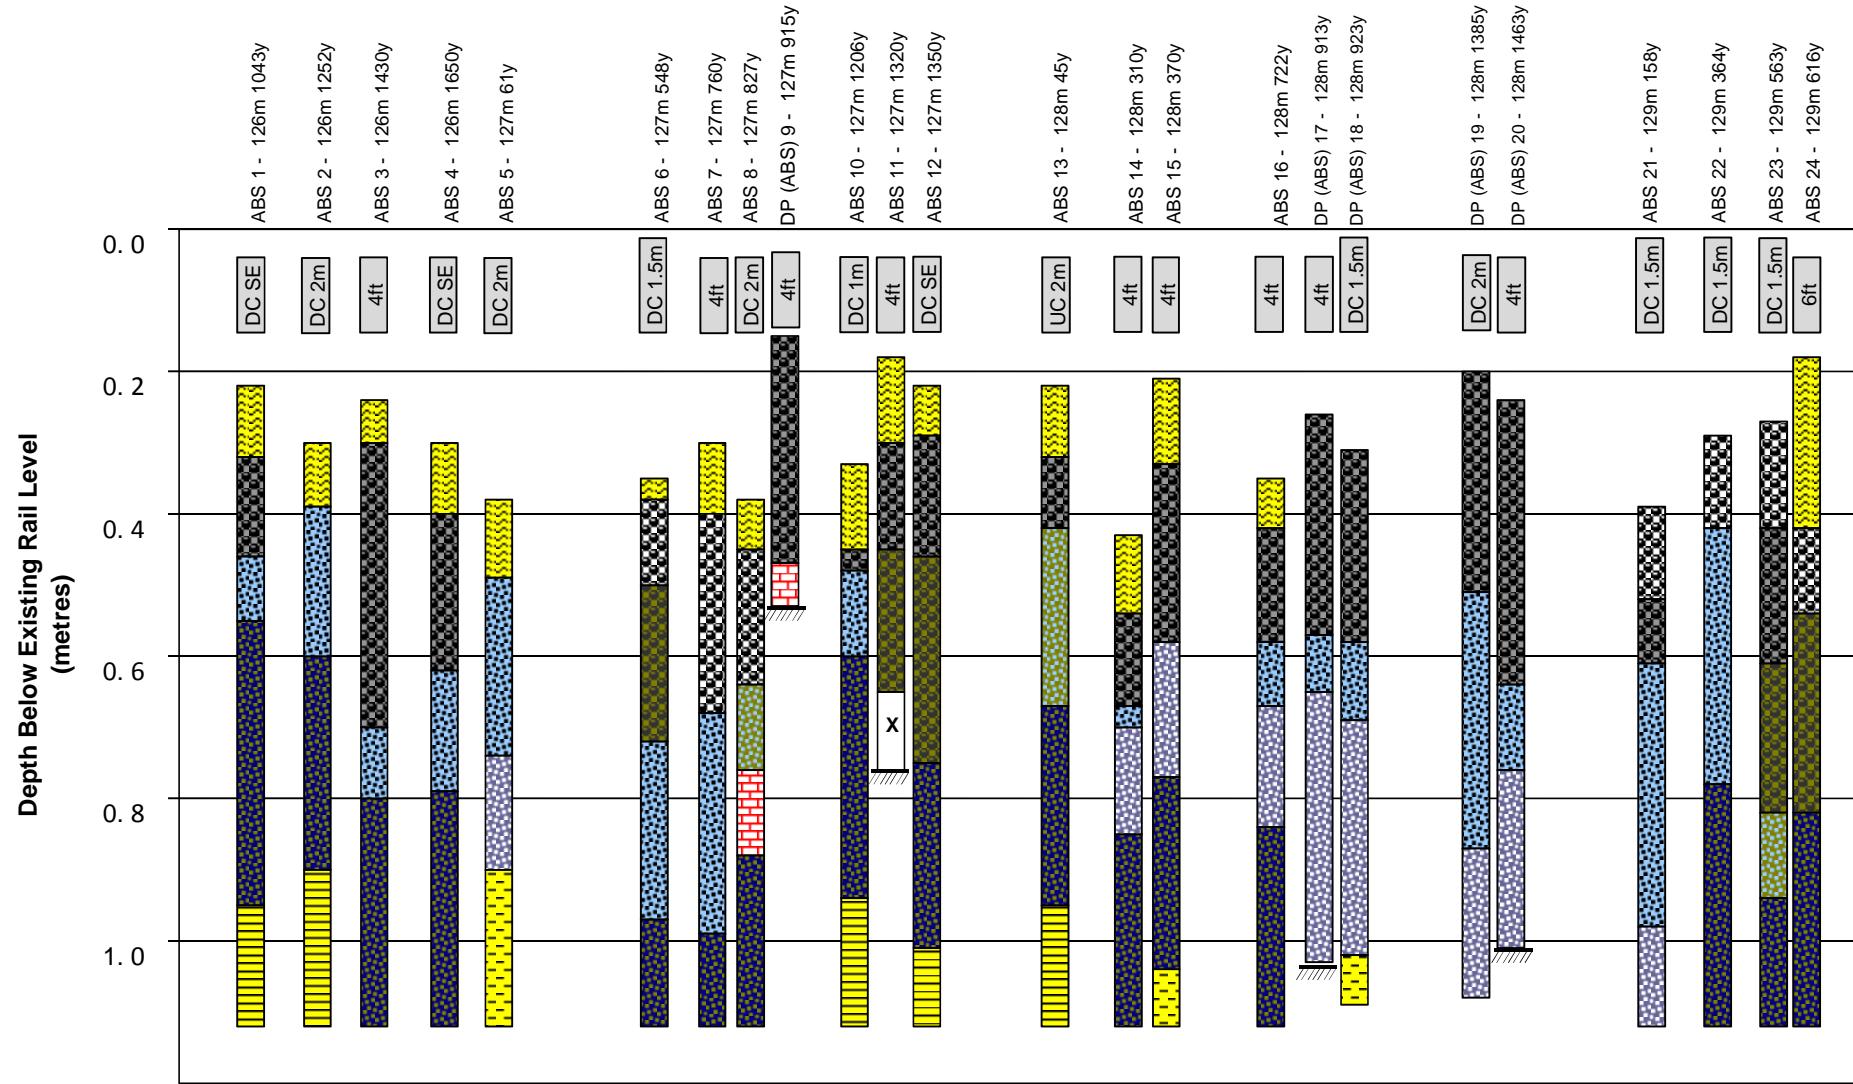
FIGURE 1A:

Samples show the upper trackbed has been predominantly covered by 50-100mm of organic soil which has intermixed with the underlying materials which make up the trackbed – mainly degraded ballast, coarse ash and other coarse granular materials. Trackbed materials are contaminated to varying extents by clay.

Below the soil, upper trackbed materials are mainly the aged and degraded original ballast (of igneous and calcareous rock) the thickness of which is variable, but often extending to a depth of 200mm below the existing sleeper base. Coarse ash material is typically underlying the former ballast layer.

FIGURE 1A
Metrowest Phase 1 - Trackbed Investigation
LONGITUDINAL SECTION
POD - REVERSIBLE - 126m 1043y to 129m 616y

The current condition of the railway trackbed through this site is not suitable for the passage of traffic without complete renewal of the trackbed. The former ballast material is degraded, undersized and has been contaminated with fines. Soils and heavy vegetation cover the surface of the trackbed, with frequent shrubs, small and mature trees growing in the 4ft and Cess of the track.

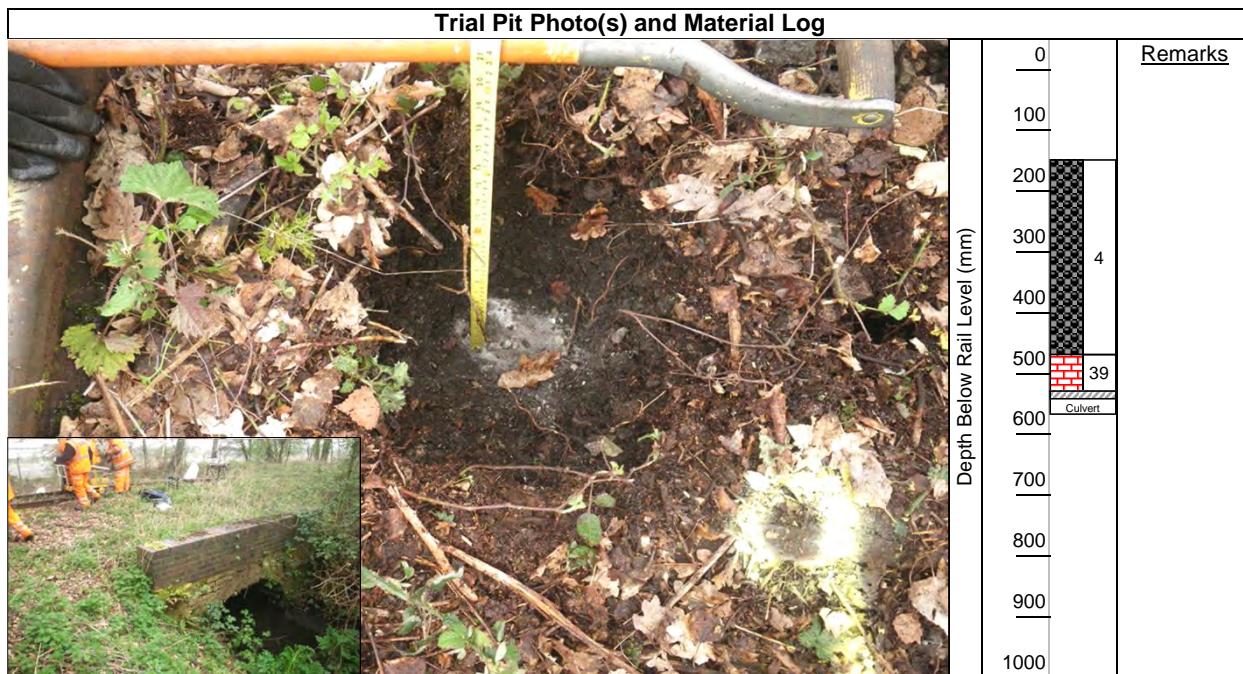
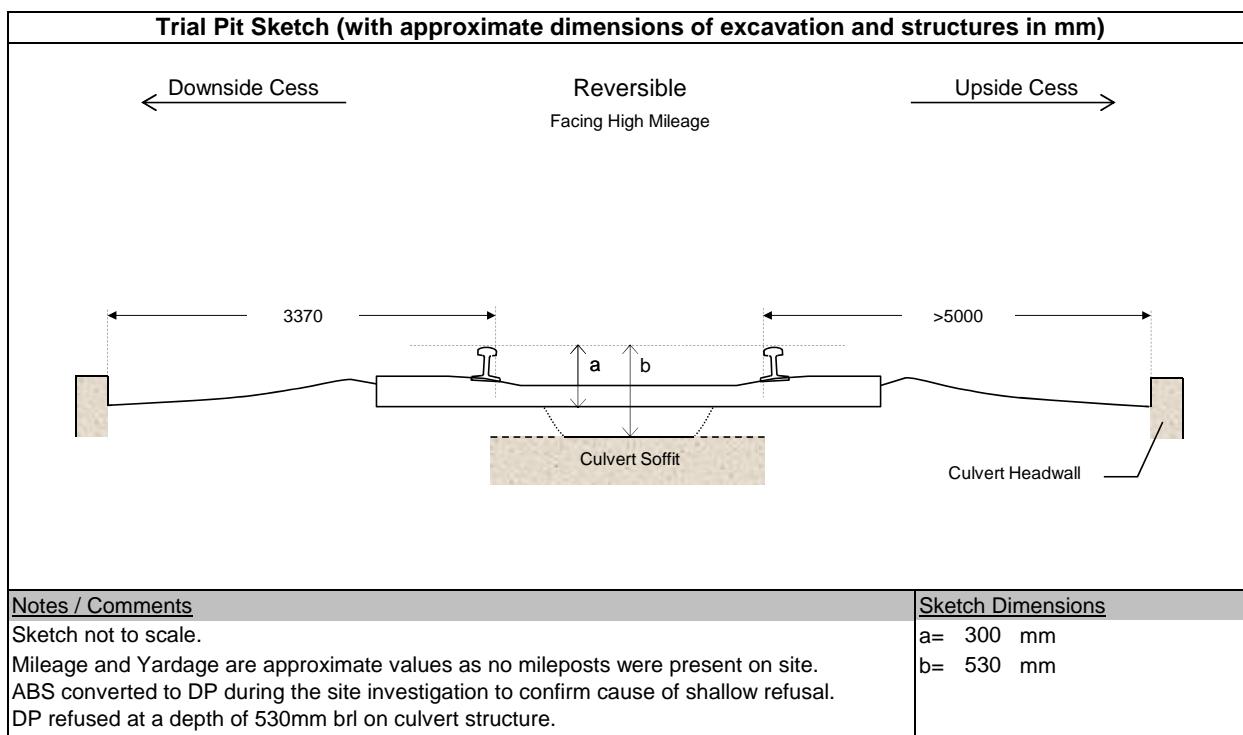
Prepared	JWM	APPENDIX B - DP ABS 9 Metrowest Phase 1 - Trackbed Investigation TRIAL PIT LOG POD - REVERSIBLE
Checked	DGK	
Job No	47070043	
Date	Apr '14

Trial Pit Details					
Pit Type / Number		DP ABS 9	Trial Pit Purpose		Assess clearances to Culvert
Mileage		127m 915y	Reason for termination		Structure encountered
Line Position		Reversible 4ft	Structure Reference		Unknown
Rail Type		Flat Bottom JR	Trackbed conditions encountered (mm below rail level)		
Sleeper Type		Timber	Wet Material		None
Weather	Prior SI	Dry	Standing Water		None
	During SI	Dry	Slurry Material		None
Date of Inspection		03/04/2014	Geosynthetics	Depth	None
Inspected by		JWM		Type	N/A

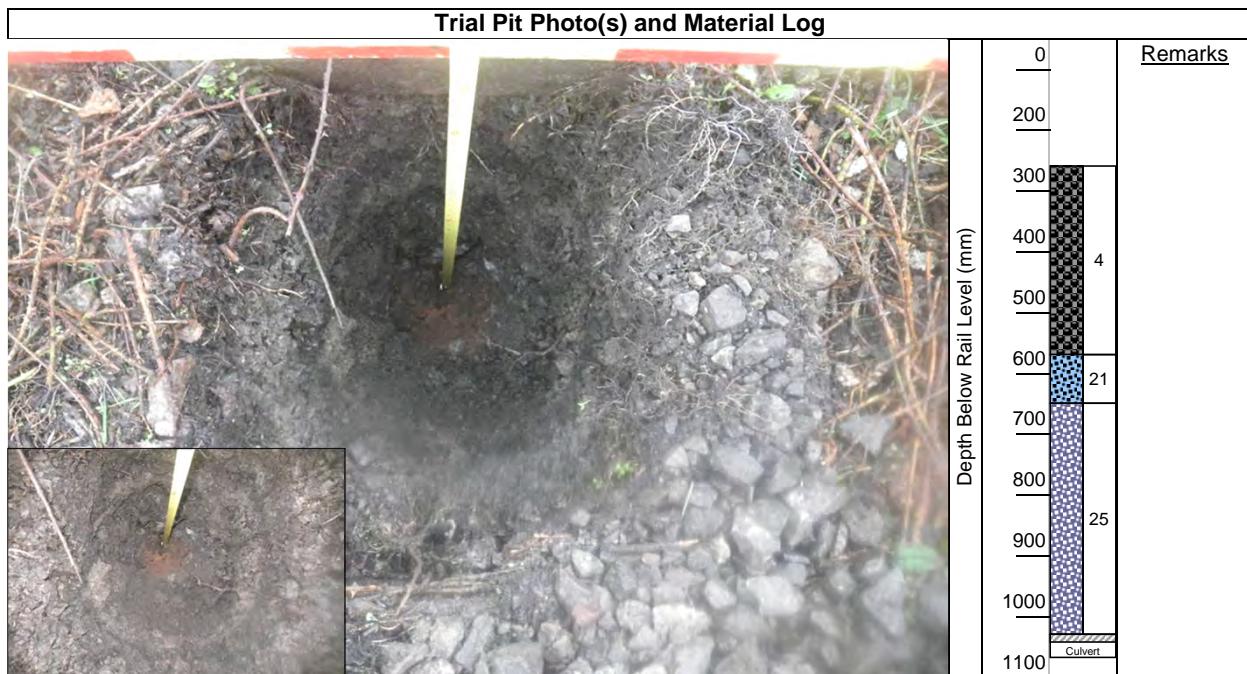
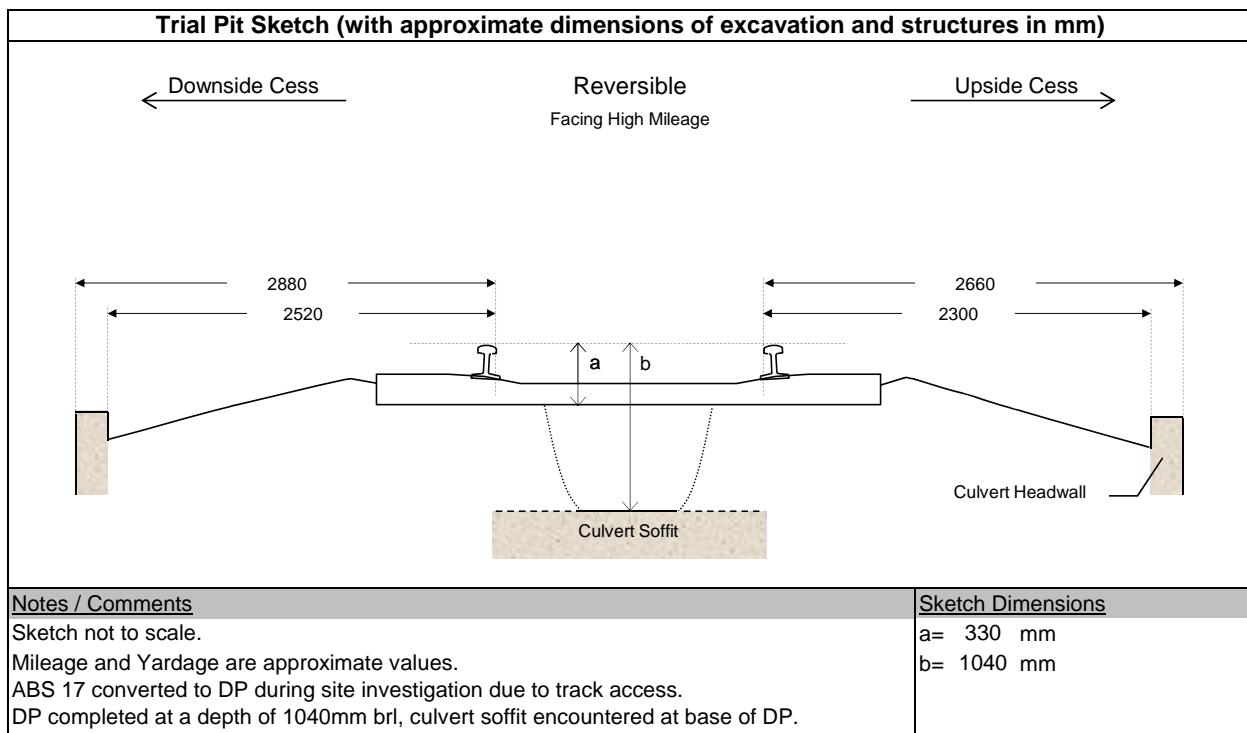
Trial Pit Details					
Pit Type / Number	DP ABS 17		Trial Pit Purpose	Assess clearances to Culvert	
Mileage	128m	913y	Reason for termination	Structure encountered	
Line Position	Reversible	4ft		Structure Reference	
Rail Type	Flat Bottom JR		Trackbed conditions encountered (mm below rail level)		
Sleeper Type	Timber		Wet Material	None	
Weather	Prior SI During SI	Wet Wet	Standing Water	None	
Date of Inspection	02/04/2014		Slurry Material	None	
Inspected by	JWM		Geosynthetics	Depth	None
				Type	N/A

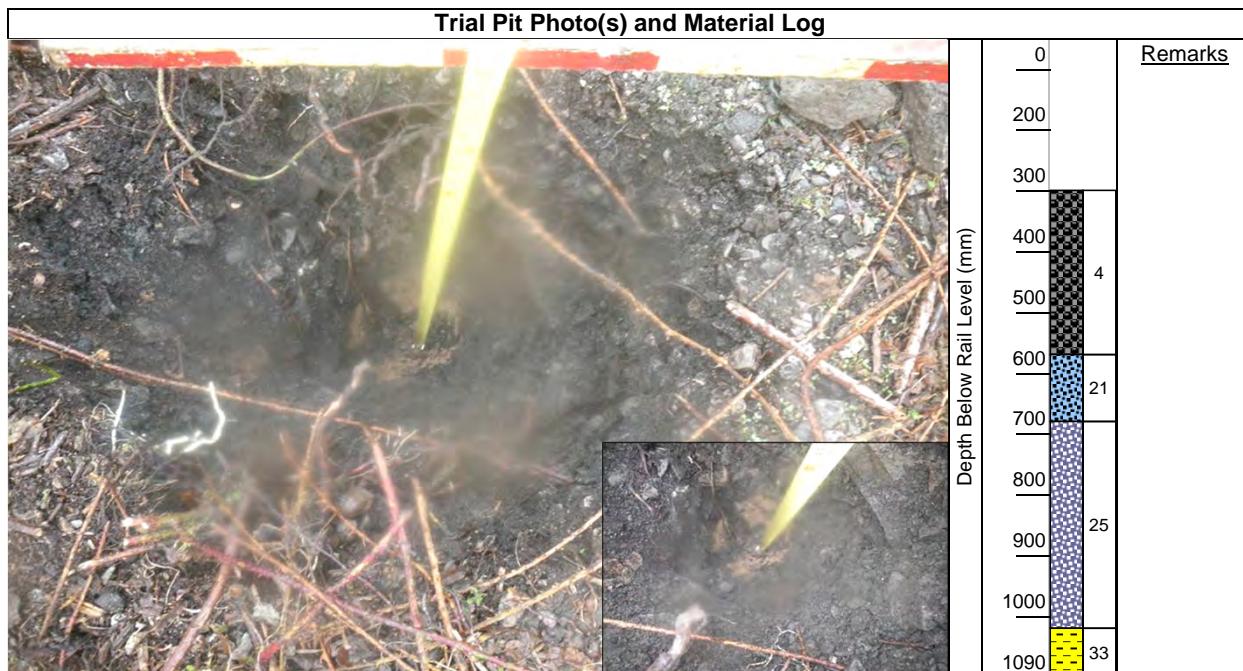
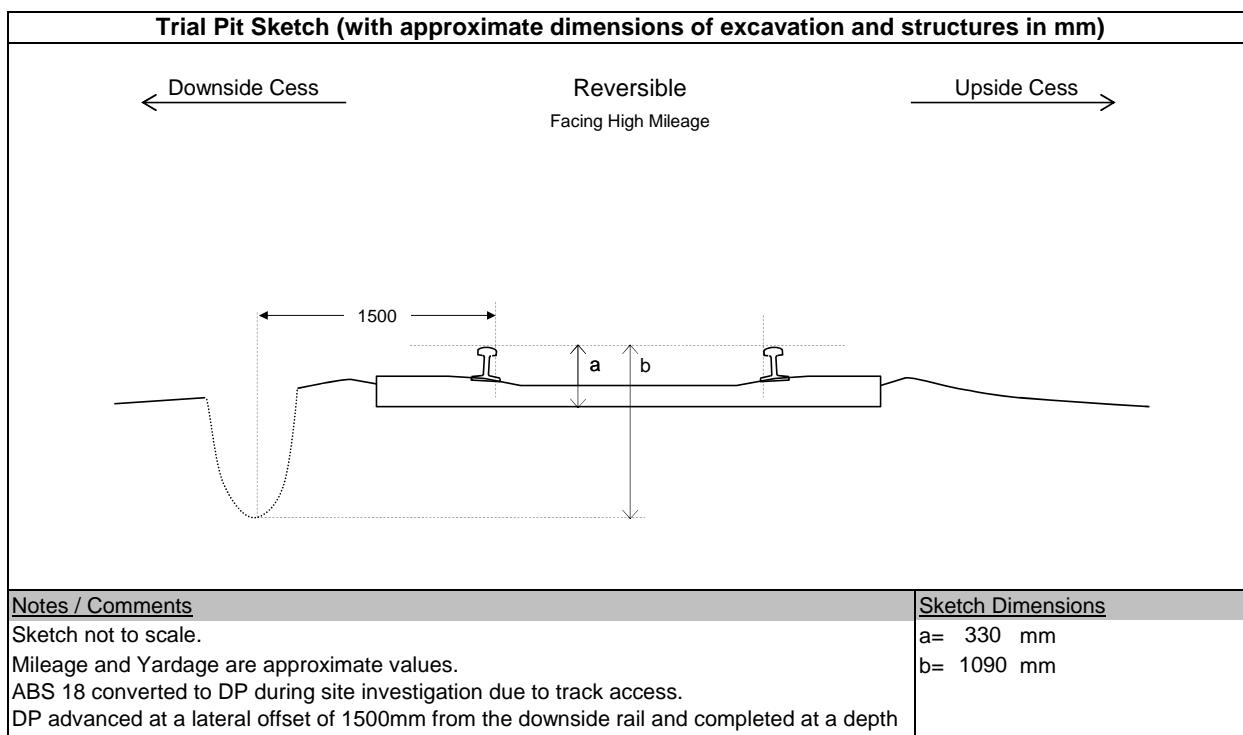
Trial Pit Details					
Pit Type / Number		DP ABS 18		Trial Pit Purpose	
Mileage	128m	923y	Reason for termination		Design depth achieved
Line	Reversible		Structure Reference		N/A
Position	Cess	Trackbed conditions encountered (mm below rail level)			
Rail Type	Flat Bottom JR	Wet Material		None	
Sleeper Type	Timber	Standing Water		None	
Weather	Prior SI During SI	Wet Wet	Slurry Material		None
Date of Inspection	02/04/2014	Geosynthetics	Depth	None	
Inspected by	JWM		Type	N/A

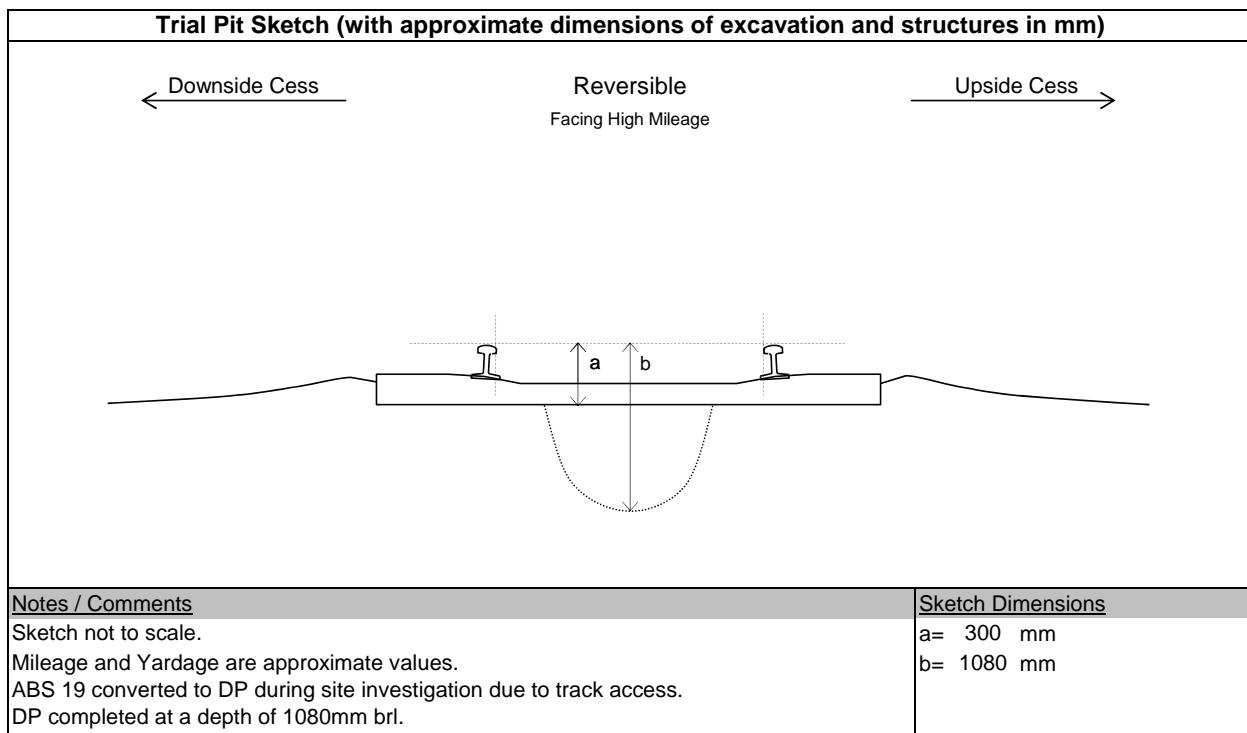
Trial Pit Details					
Pit Type / Number		DP ABS 19		Trial Pit Purpose	
Mileage		128m	1385y	Reason for termination	
Line		Reversible		Design depth achieved	
Position		4ft		Structure Reference	
Rail Type		Flat Bottom JR		Trackbed conditions encountered (mm below rail level)	
Sleeper Type		Timber		Wet Material	None
Weather	Prior SI During SI	Wet Dry		Standing Water	None
				Slurry Material	None
Date of Inspection		02/04/2014		Geosynthetics	None
Inspected by		JWM		Depth Type	N/A

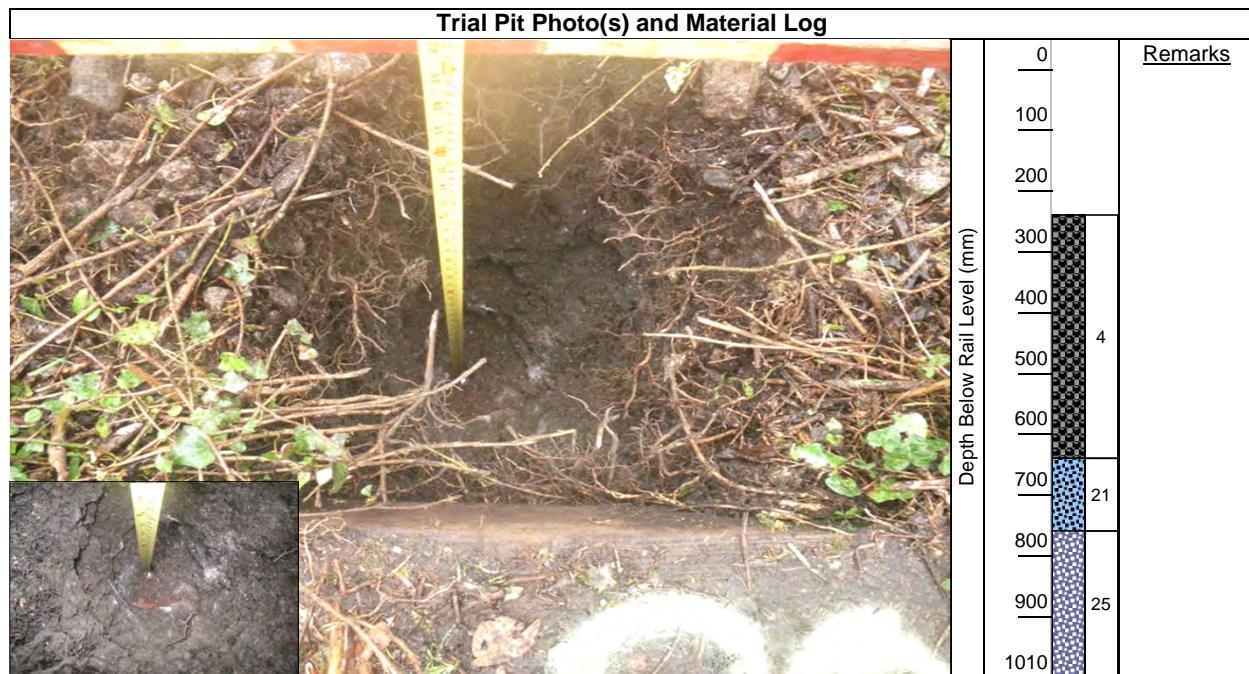
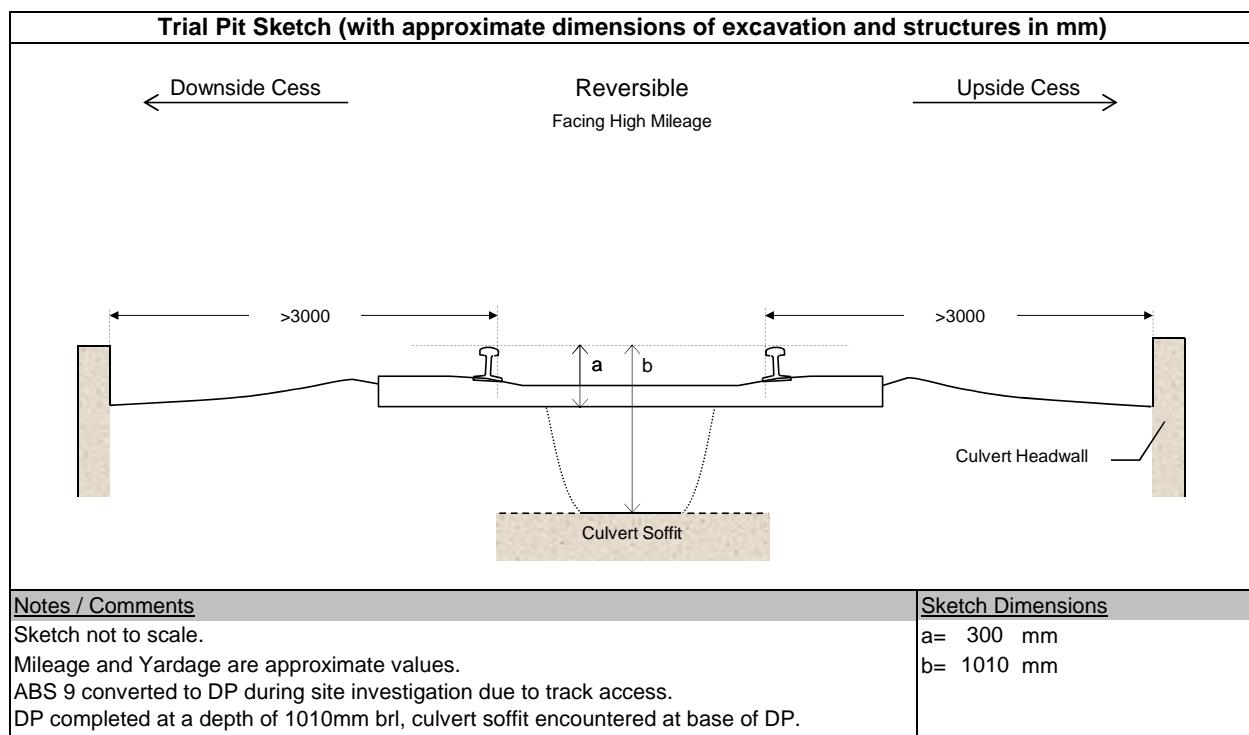
Trial Pit Details					
Pit Type / Number	DP ABS 20		Trial Pit Purpose	Assess clearances to Culvert	
Mileage	128m	1463y	Reason for termination	Design depth achieved	
Line Position	Reversible			Unknown	
Rail Type	Flat Bottom JR		Trackbed conditions encountered (mm below rail level)		
Sleeper Type	Timber		Wet Material	None	
Weather	Prior SI During SI	Wet Dry	Standing Water	None	
Date of Inspection	02/04/2014		Slurry Material	None	
Inspected by	JWM		Geosynthetics	Depth	None
			Type		N/A
