## Portishead Branch Line (MetroWest Phase 1)

**6.25, Environmental Statement, Volume 4, Appendix 9.11 Avon Gorge Vegetation Management Plan**

**Author: CH2M**

**Date: November 2019**

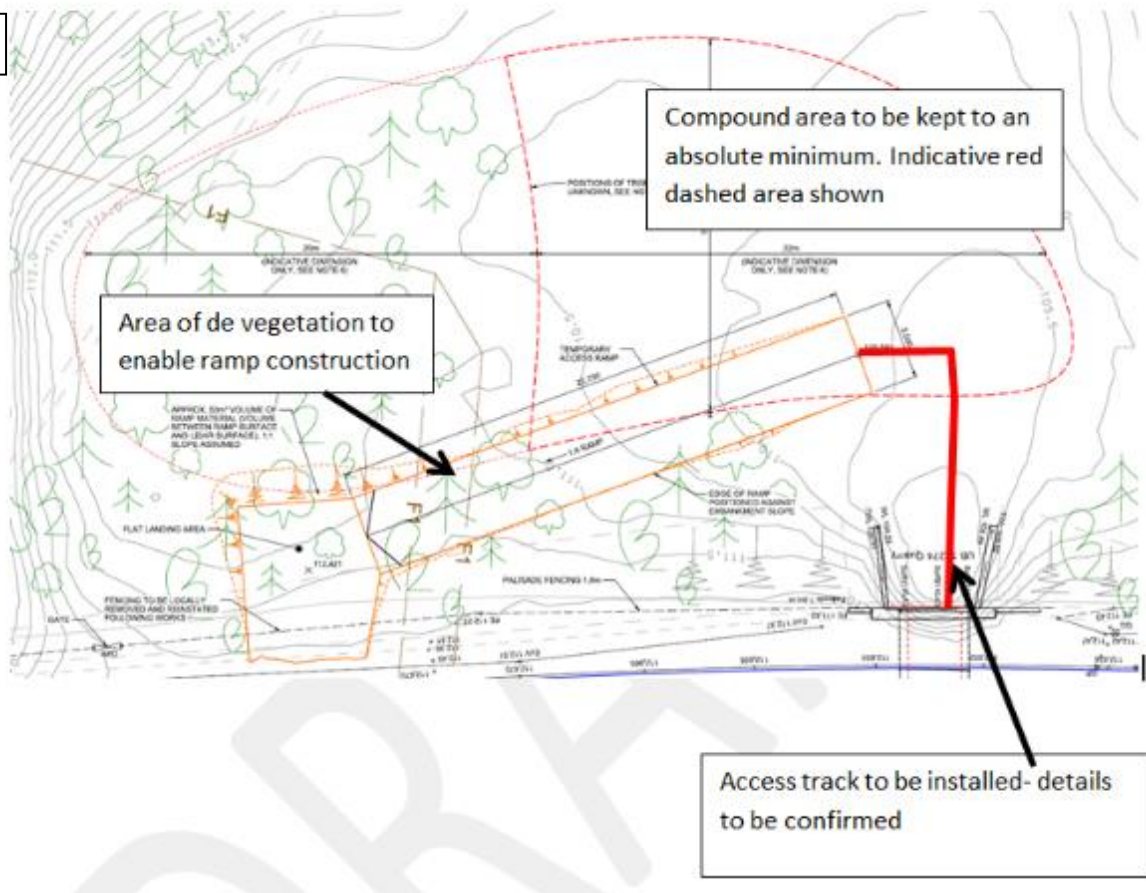
Figure 3

Recommended Location for Works Compound

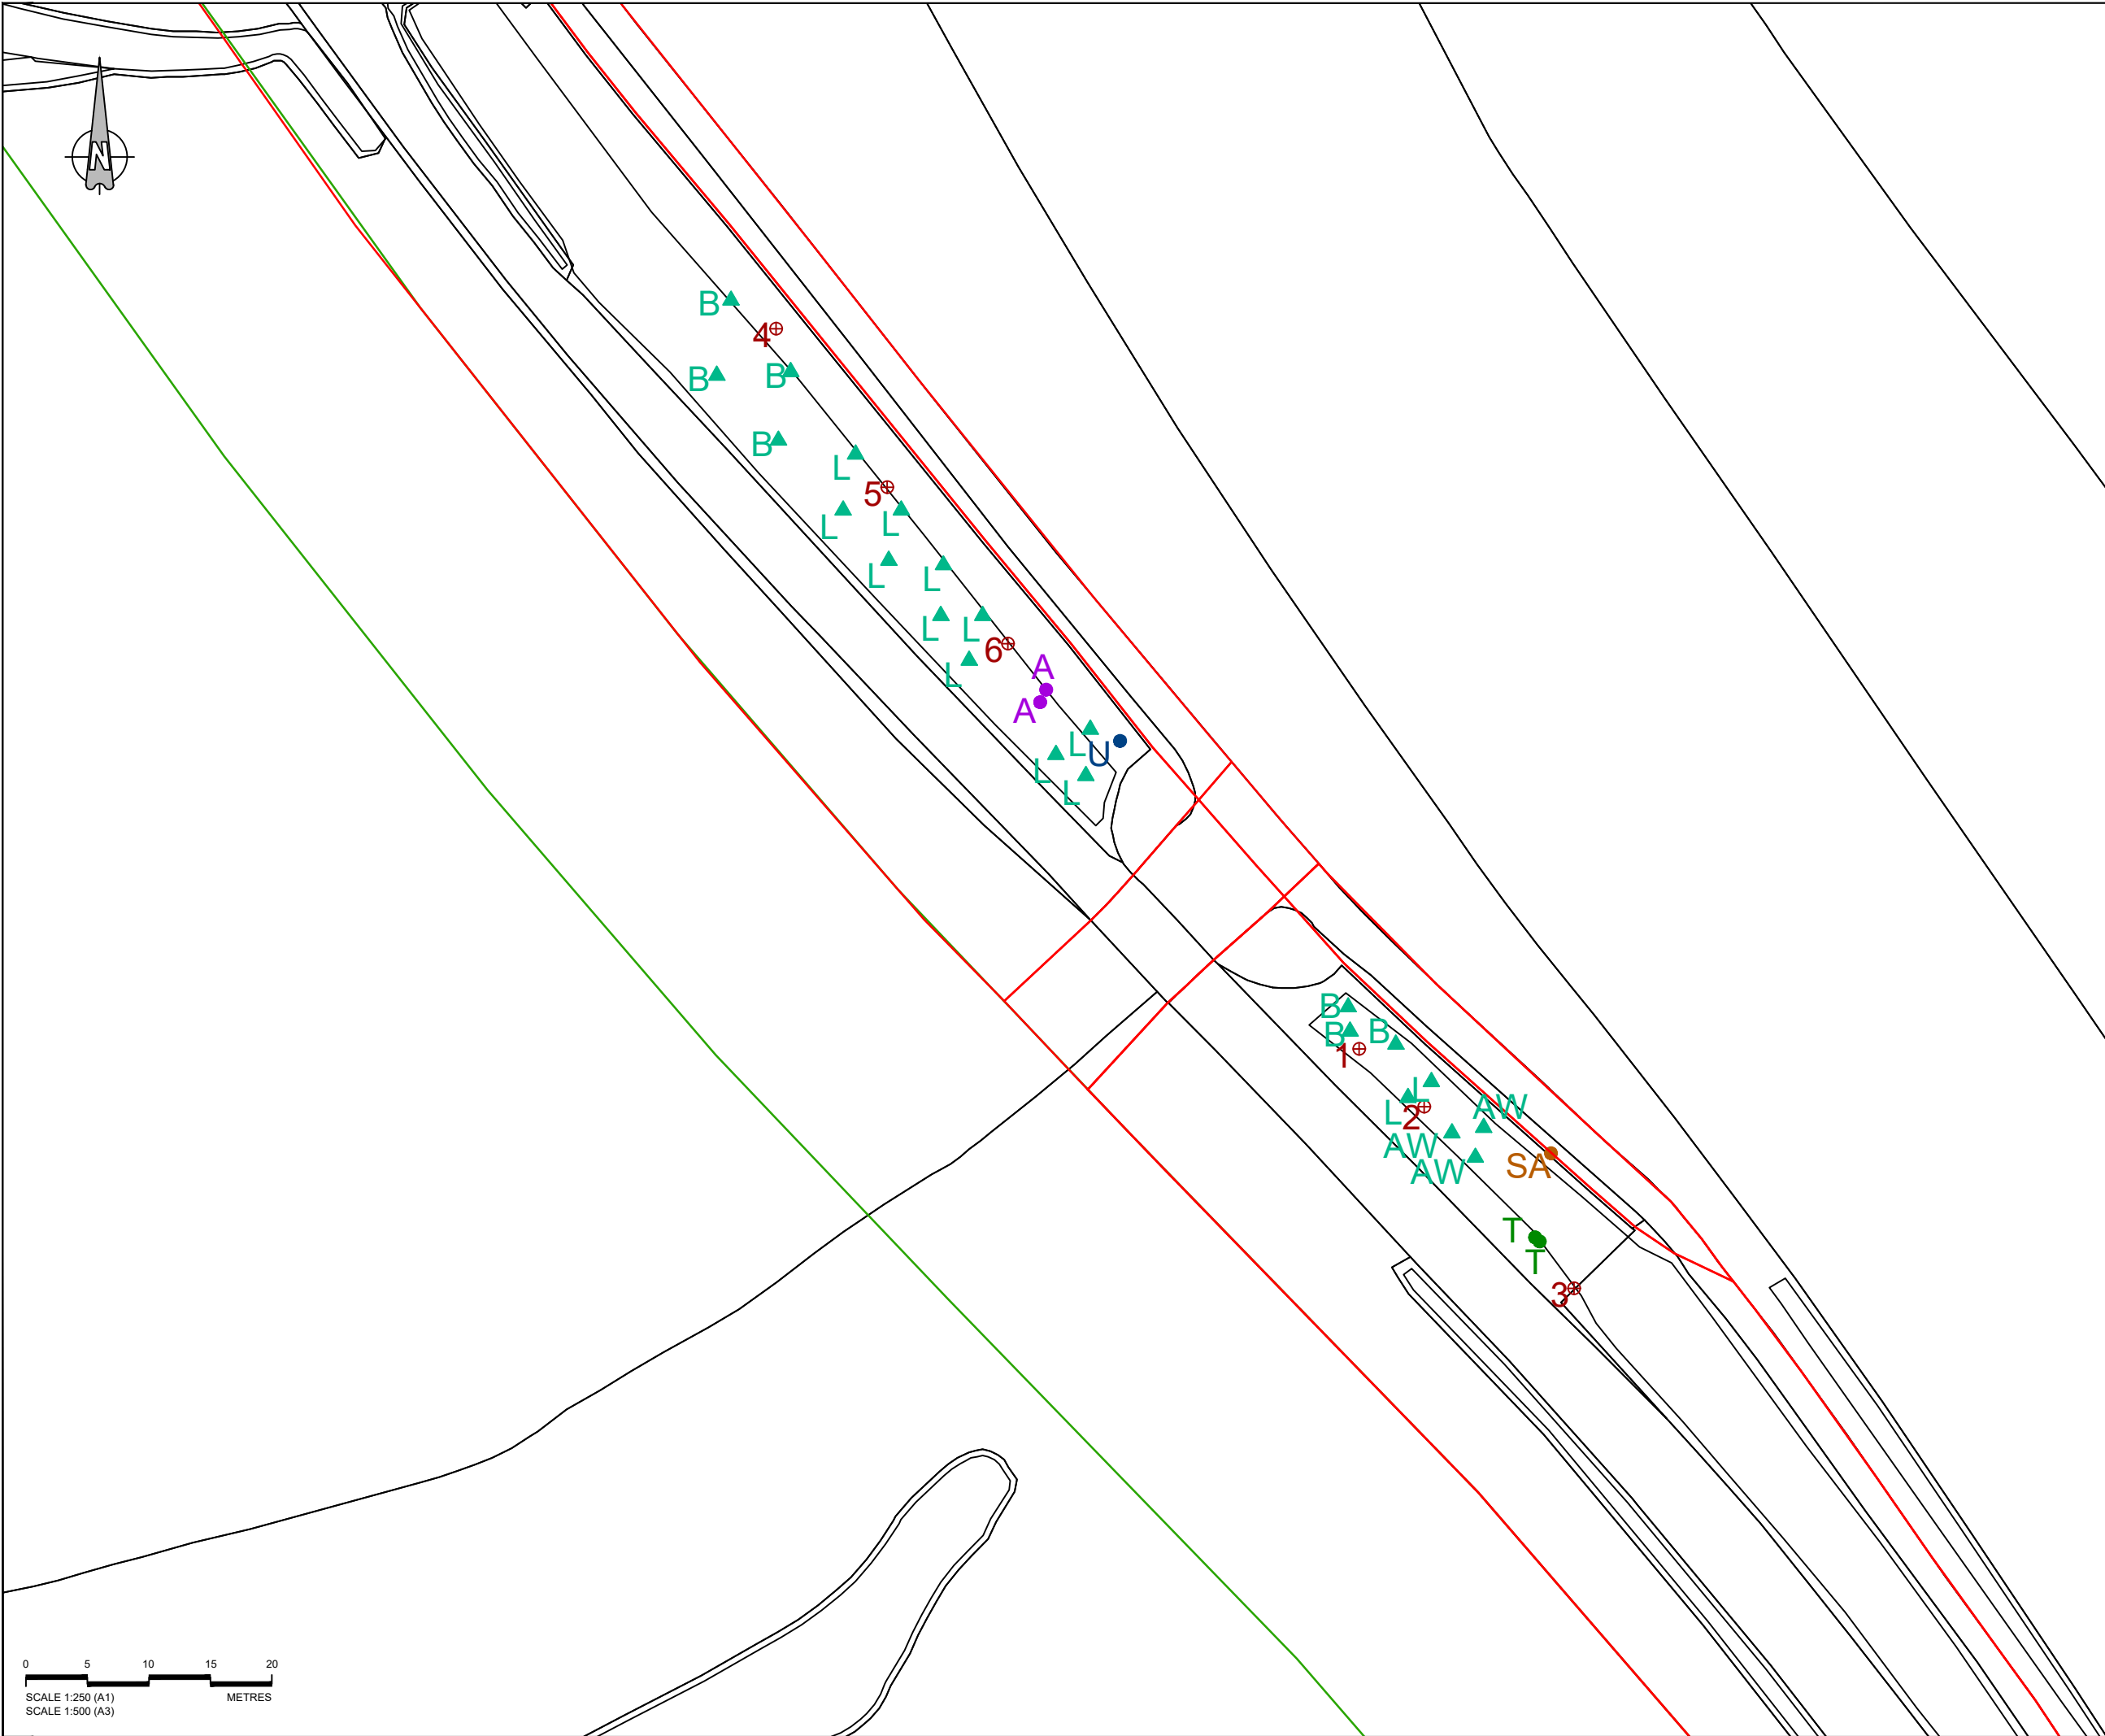
- △ TREE - PROPOSED
- TREE - EXISTING, TO BE RETAINED
- ⊕ SOIL PITS
- T TILIA CORDATA
- SA SORBUS AVONENSIS
- U ULMUS GLABRA
- A ACER CAMPESTRE
- AW AVON WHITEBEAM
- B BRISTOL WHITEBEAM
- L LEIGH WOODS WHITEBEAM
- PERMANENT LAND TAKE

- 2.3.2. The southern part of the planting site is on the east-facing embankment between the freight line and River Avon Tow Path at Nightingale Valley, south of Valley Bridge (Figure 2). The planting site covers 350 m<sup>2</sup> south of Valley Bridge (35 m long and 10 m wide). The lower side is bounded by a wall c. 1.5 m tall and the upper side is fenced from the railway.

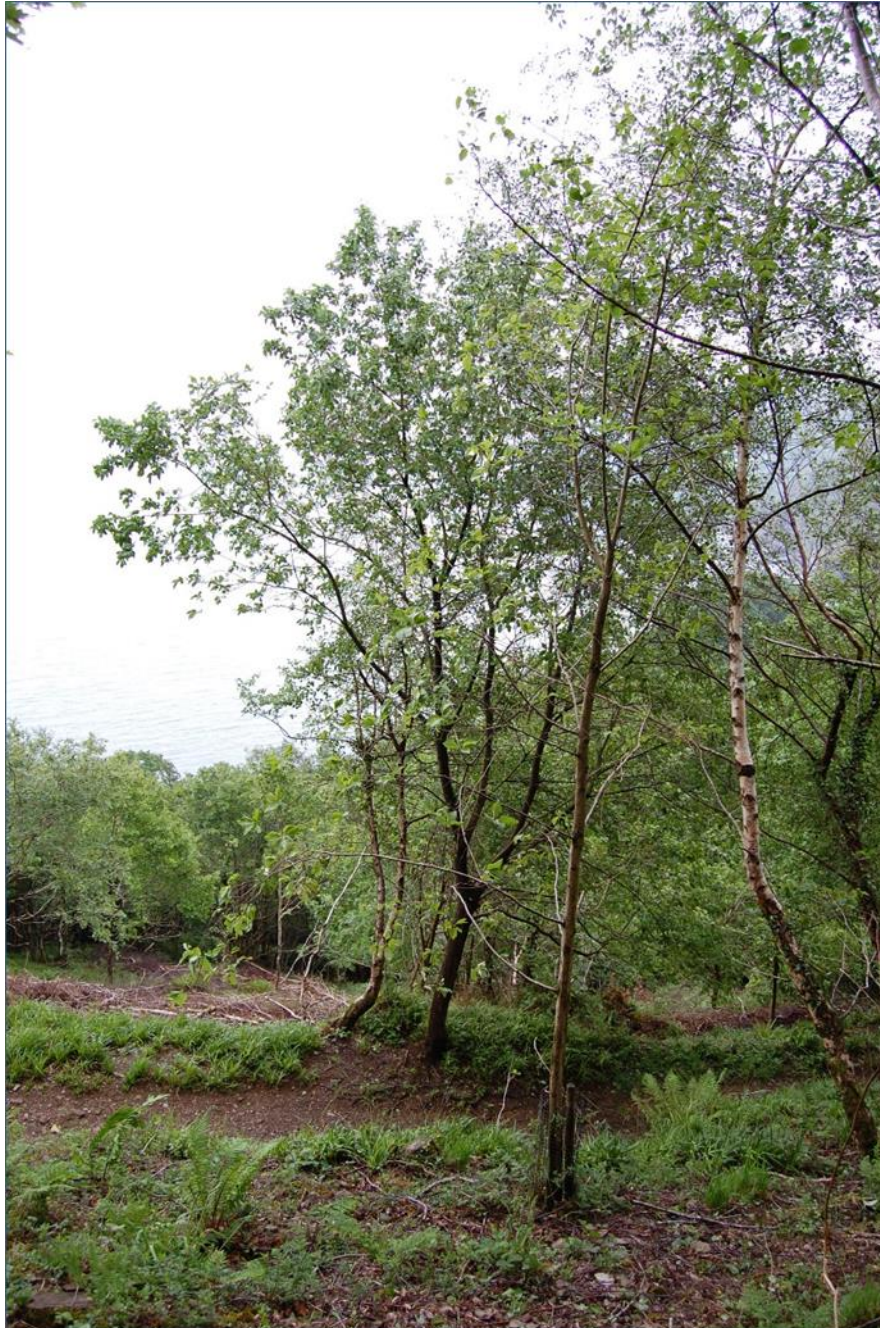
**Photograph 6. Devon whitebeam planted out at Woody Bay, 2015, showing survival since planting in the early 1990s (note the stakes holding the original sapling)**

whitebeam species, together with other trees to restore the woodlands. No information has been seen on the full details of what was planted where (although the seeds must have been sourced locally). The replanted trees are still easily identified by the stakes and the two trees observed by Dr Rich in 2015 were healthy and growing well (Photograph 6). Deer are widespread in these woodlands.

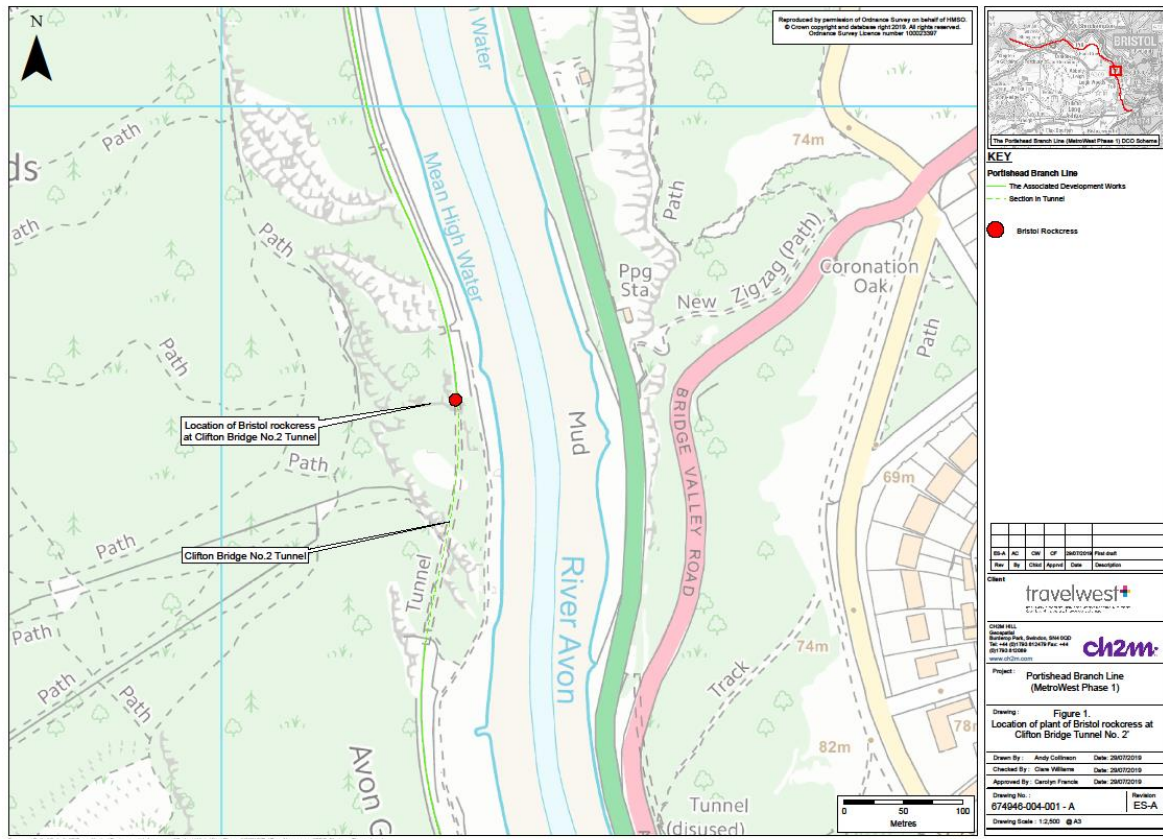
**Figure 1. Location of plant of Bristol rockcress at Clifton Bridge Tunnel No. 2**
